AEROSPACE CORP EL SEGUNDO CALIF ENGINEERING SCIENCE --ETC F/6 9/5
ALUMINA SUBSTRATE ASSEMBLY STUDY.(U)

Alumina Substrate Assembly Study

1 October 1976

Final Report

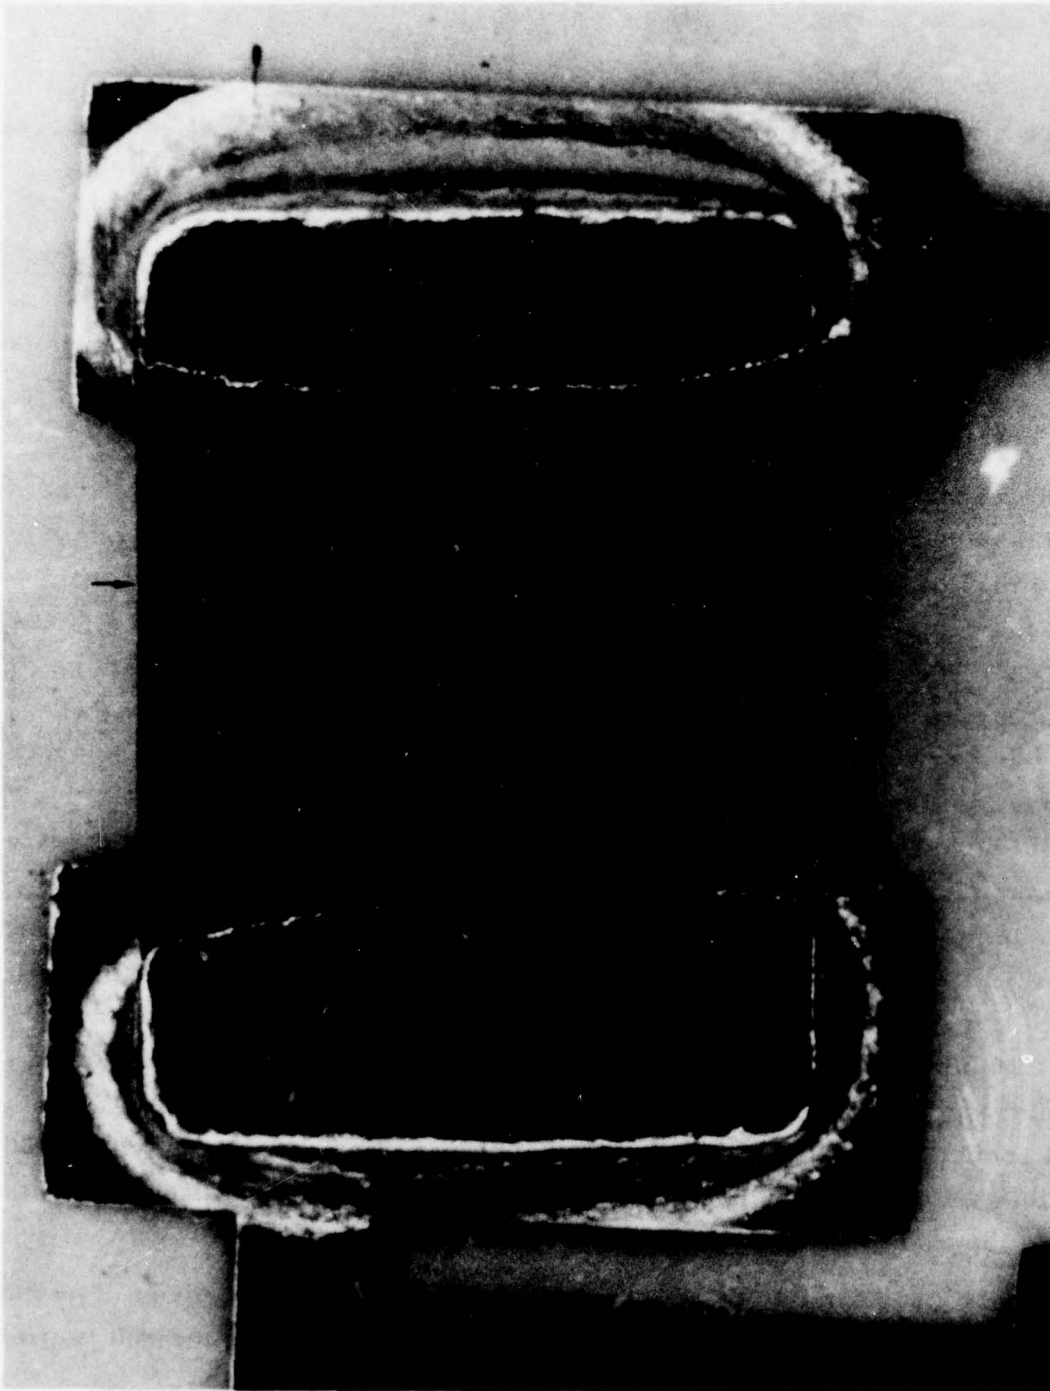
The capacitor network 3 in module 003 exhibited intermittent noise during the vibration and shock testing. The components exhibited minor noise (15 mV) during Z-axis vibration at room temperature. This noise increased to 50 mV during z-axis vibration at test temperature extremes (-35°C and $+60^{\circ}\text{C}$). The noise continued in the Z axis, but was not observed in the Y axis. During shock testing (2500 g) the noise increased to approximately 800 mV, and erratic readings were noted during the 30-min recovery period. The capacitor network 3 performed without incident during the subsequent 200 thermal cycles from -46°C to $+60^{\circ}\text{C}$; however, it failed open shortly after commencing the 800 temperature cycles from -50°C to $+100^{\circ}\text{C}$. Upon opening the module, a crack was observed across the center of C26, a 100,000 pF ceramic capacitor. (See Figure 25.) After removal of the capacitor by TRW, the crack could be seen on all four sides of the part. The failure analysis on C26 performed by TRW (see Appendix C) concluded that the cause of the failure was unknown. They had observed similar cracks resulting from thermal shock, but had no indication that vibration or shock testing (to 10,000 g) caused this failure mode. TRW speculated that a combination of thermal shock and vibration or mechanical shock could induce the defect.

Figure 25. Photomicrograph of Failed Capacitor C26. (The arrows show the position of the crack that goes through the body of the capacitor.)

Following a detailed failure analysis of capacitor C26, it was concluded that the cause of the failure was unknown. That is, it was felt that, based on extensive test data, the circumferential crack in the center of the ceramic body could not have been caused by the vibration, shock, or temperature cycling.

The two pads for C26 were jumpered and testing was resumed. Two more capacitors in network 3 in module 003 exhibited failures during the 800 thermal

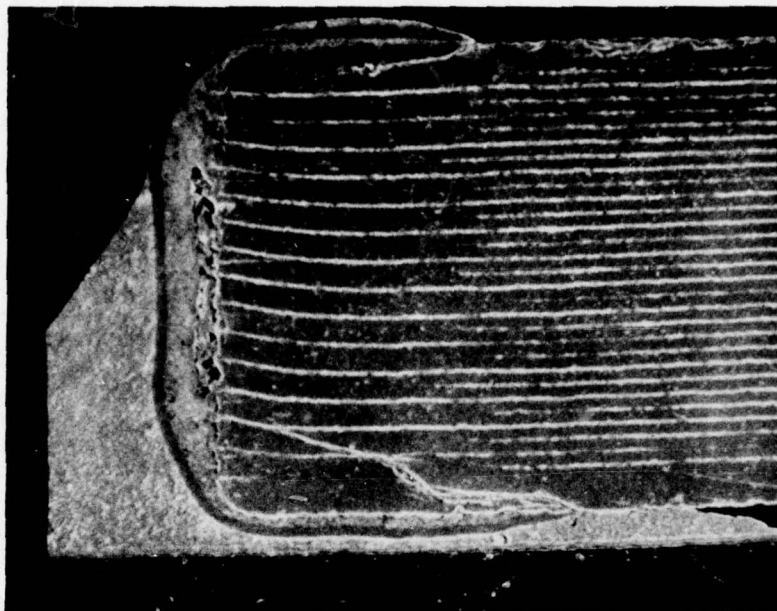
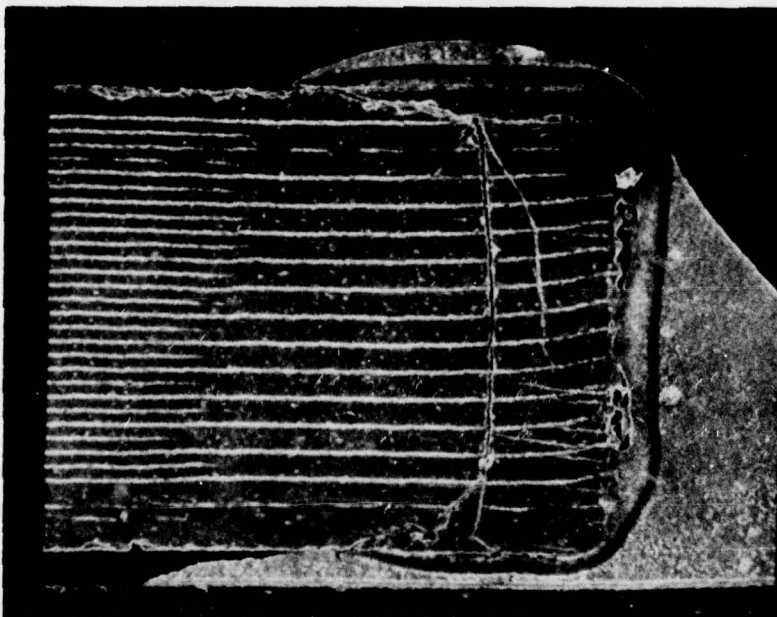
cycles ranging from -50°C to $+100^{\circ}\text{C}$. Capacitor C23 (10,000 pF, ceramic) was intermittent and finally failed open. Capacitor C24 (10,000 pF, ceramic) was observed in post-test measurement to have changed values. Since module 003 underwent no Phase II testing, the examination of capacitors C23 and C24 was accomplished in the final cross sectioning of the module at The Aerospace Corporation. Figures 26(a) and (b) are scanning electron microscope (SEM) photos of the end cap areas of C23. Cracks originate at about the edge of the metallization, both top and bottom. These cracks extend under the end cap for some distance and are then joined by a crack that is roughly parallel to the end of the capacitor. It is evident that the open was caused by the crack which completely traverses the ceramic body. Other minor cracks are also evident in the end cap area, and voids are present in the end cap metallization. Figures 27(a) and (b) are SEM photomicrographs of the end cap regions of C24. Voids can be seen in the end cap metallization and could easily explain the observed intermittency.

Figure 26. Scanning Electron Micrograph of the End Cap Areas of Capacitor C23 in Cross Section. (It should be emphasized that the major portion of the capacitor exhibited no cracking. Extensive cracking may be seen to originate at the ends of the end caps and radiate through the ceramic toward the end of this BX-type capacitor. The crack that is parallel to the end cap may be seen clearly in b.)

The crack that caused failure of capacitor C23 is located under the end cap. One cause for this type of failure has been suggested in preliminary work at TRW (Ref. 4). This study indicated that there is a definite correlation between this type of crack and the thickness of the copper barrier plating on the end cap for Union Carbide type BX capacitors. This failure can be observed to a greater or less degree in capacitors C23, C24, and C25 (Figures 26, 27, and 28 respectively). However, this failure mode was not observed with Union Carbide's NPO-type capacitors. This was confirmed in the present study in the cross section of unit C22 (Figure 29) which is of the NPO type. The intermittency in C24 could easily have resulted from cracking in the ceramic under the end cap or from the poor contacts in the end cap metallization.

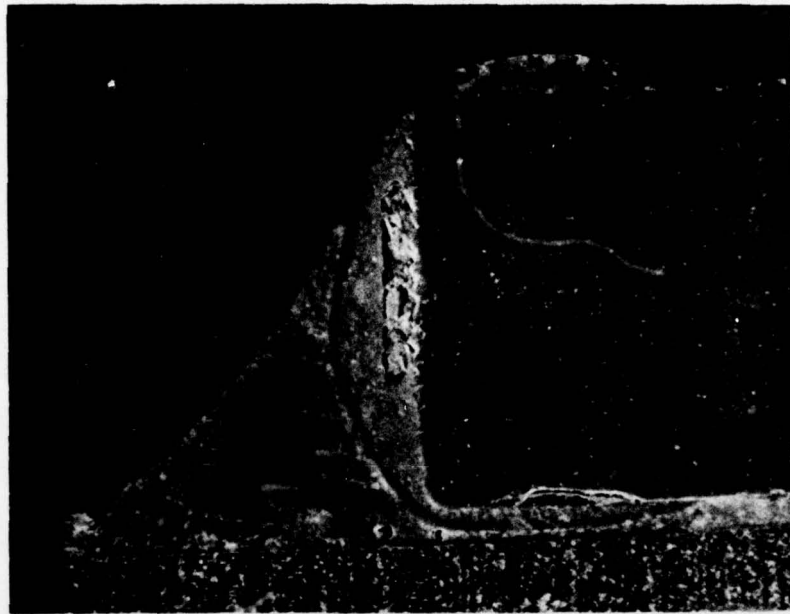
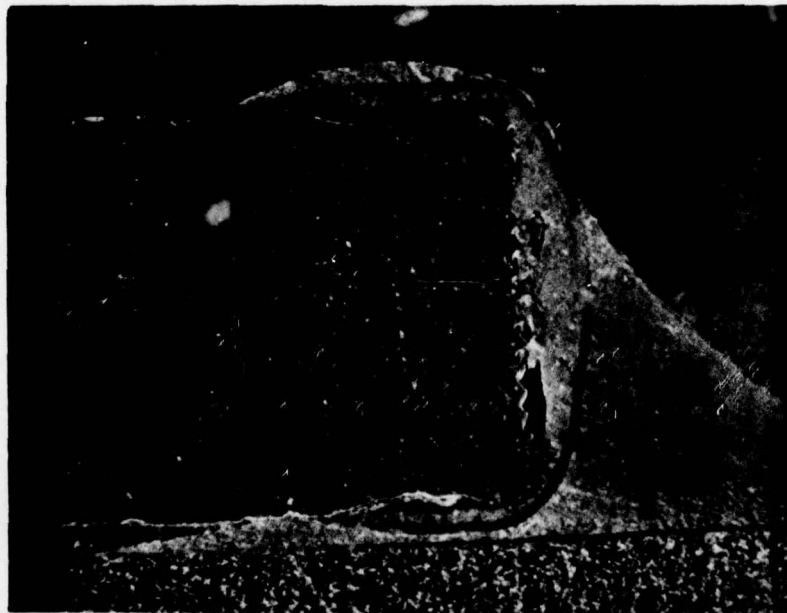
Figure 27. Scanning Electron Micrograph of the End Cap Areas of Capacitor C24. (In this BX-type capacitor no damage was observed except in the end cap areas where there was minor cracking of the ceramic and voids in the end cap metallization.)

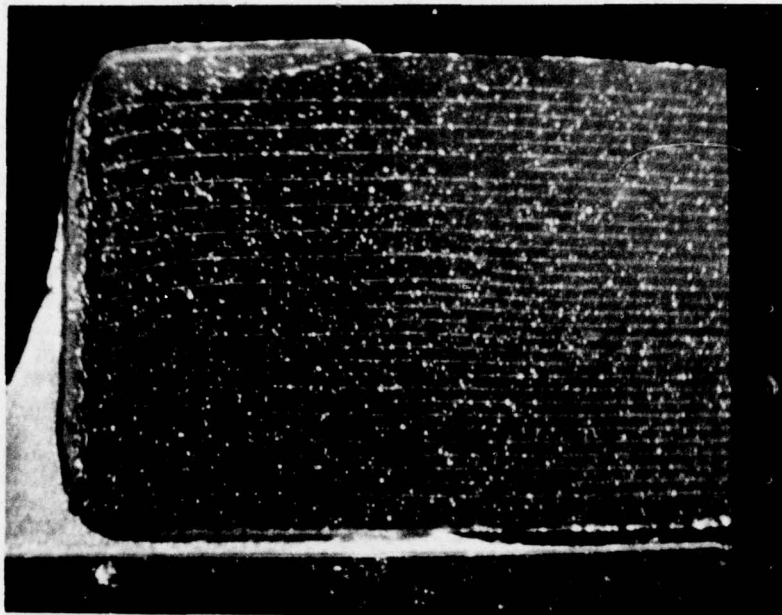
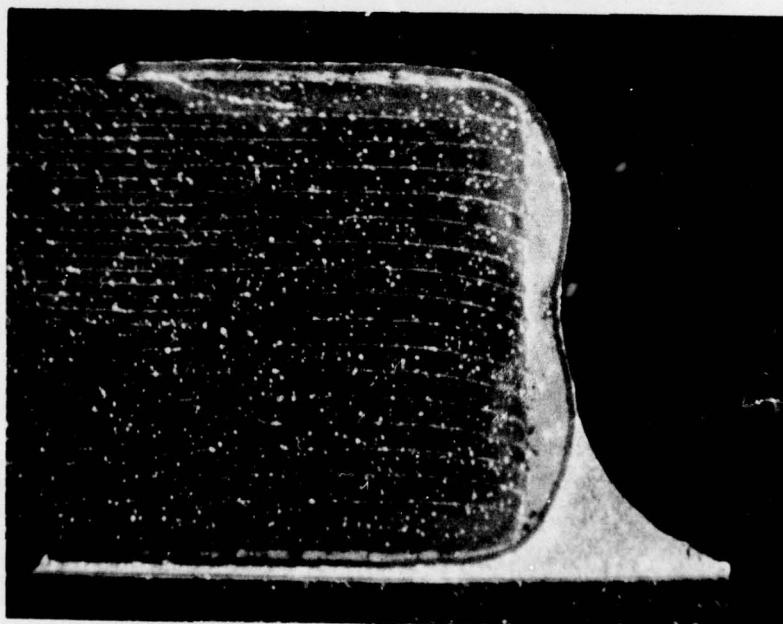
Capacitors C25 (100,000 pF, ceramic) and C22 (1800 pF, ceramic) were also examined in cross section. These are shown in Figures 28(a) and (b) and Figures 29(a) and (b) respectively. These capacitors exhibit few voids in the end cap metallization and only inconsequential cracking of the ceramic.

Figure 28. Scanning Electron Micrograph of the End Cap Areas of Capacitor C25 in Cross Section.
(Little damage was observed in this BX-type capacitor except for very minor cracking of the ceramic in the end cap area.)

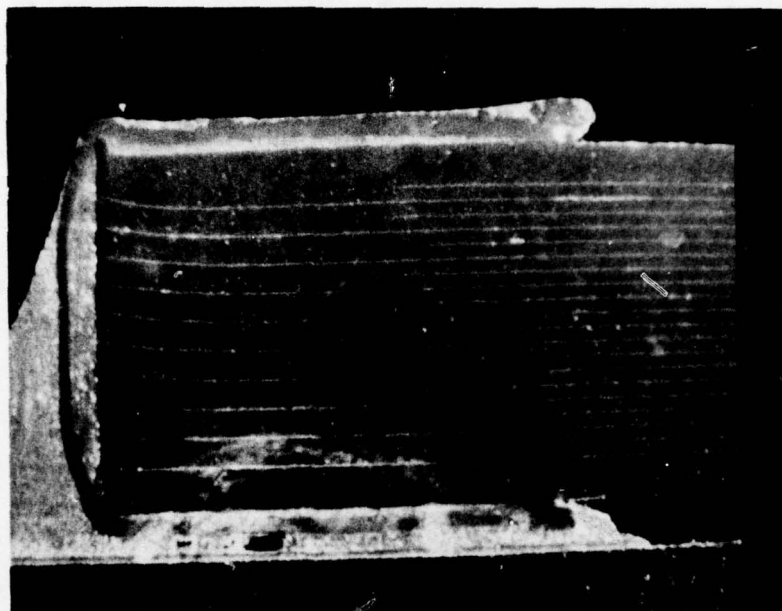
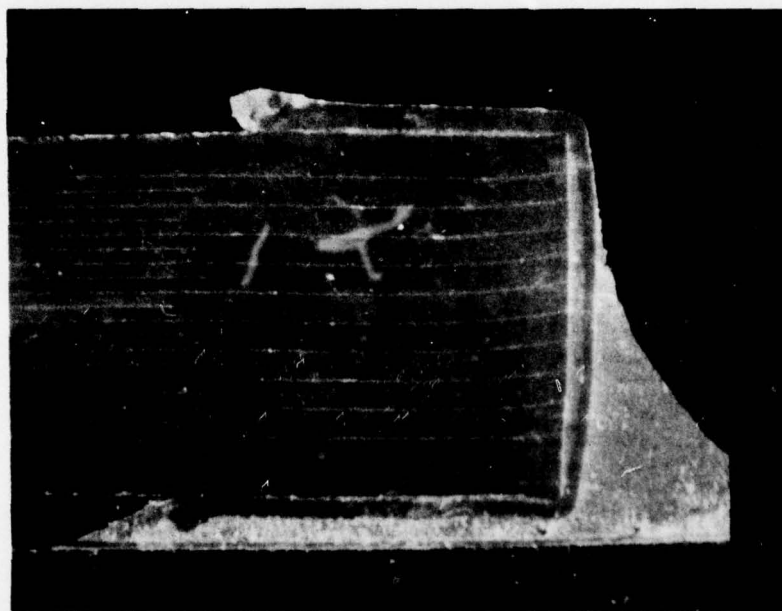
Figure 29. Scanning Electron Micrograph of the End Cap Areas of Capacitor C22 in Cross Section. (No damage was evident in the cross section of this NPO-type capacitor.)
